**INSPECTED FOR**  
**Sample Report**  
**1234 Bluebonnet Drive**  
**Austin, TX 78759**  
**January 1, 2026**

## PROPERTY INSPECTION REPORT FORM

<b>Sample Report</b>	<b>01/01/2026</b>
<i>Name of Client</i>	<i>Date of Inspection</i>
<b>1234 Bluebonnet Drive Austin, TX 78759</b>	
<i>Address of Inspected Property</i>	
<b>Tim McCoy</b>	<b>23059</b>
<i>Name of Inspector</i>	<i>TREC License #</i>

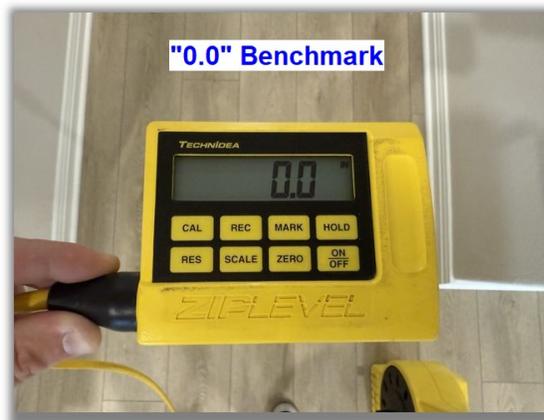
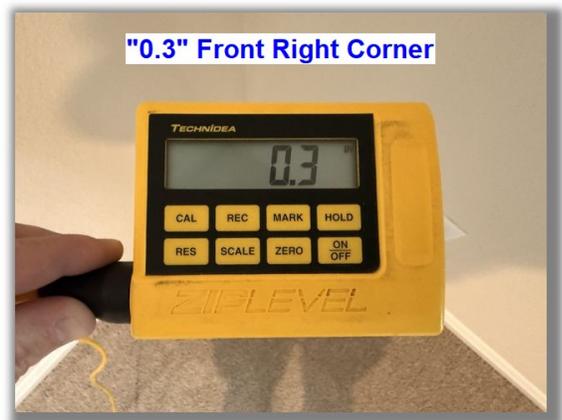
In my opinion, the foundation appears to be providing adequate support for the structure at the time of this inspection. I did not observe any apparent evidence that would indicate the presence of adverse performance or significant deficiencies in the foundation. The interior and exterior stress indicators showed little effects of adverse performance and I perceived the foundation to contain no significant unlevelness.

The purpose of this inspection was to evaluate the foundation and determine if further evaluation by a professional engineer is necessary. The foundation was visually inspected and a floor elevation survey was performed. Interior floor elevations were taken with a Technidea Pro-2000 Zipline. Elevations were recorded to the nearest 0.1-inch throughout the home. A benchmark of 0.0 was established near the center of the home and is shown on drawing with a "R". An adjustment was made for floor coverings if they were a different elevation than the floor covering at the benchmark location.

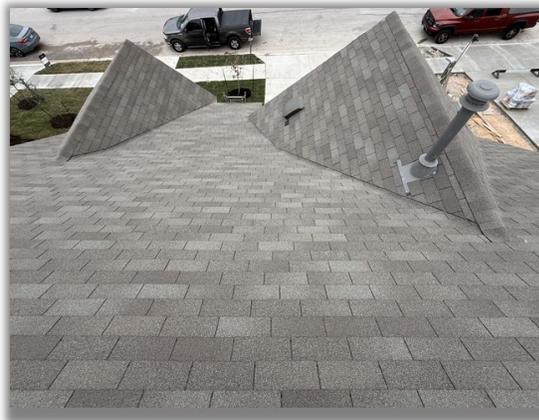
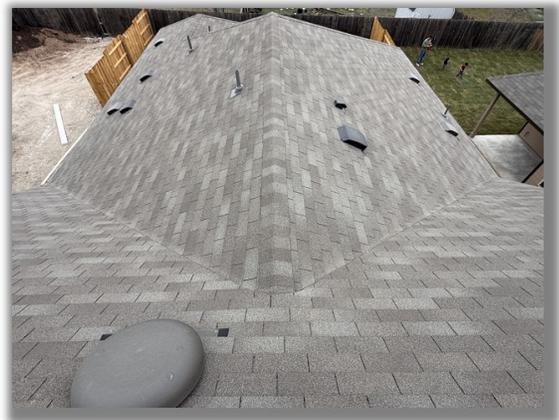
All components appear to be performing adequately on the day of this inspection. The roofing material components appears to be shedding water and achieving the operation, function or configuration relative to accepted industry standard practices with consideration of age and normal wear and tear from ordinary use.

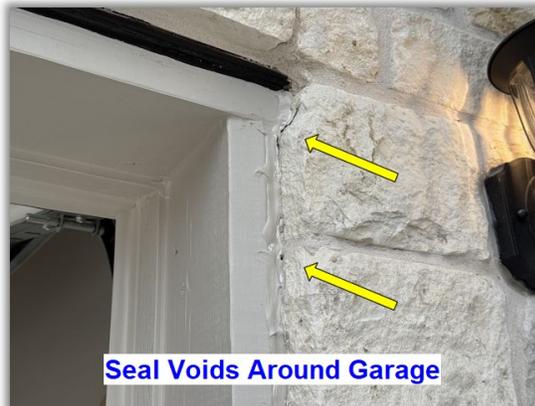
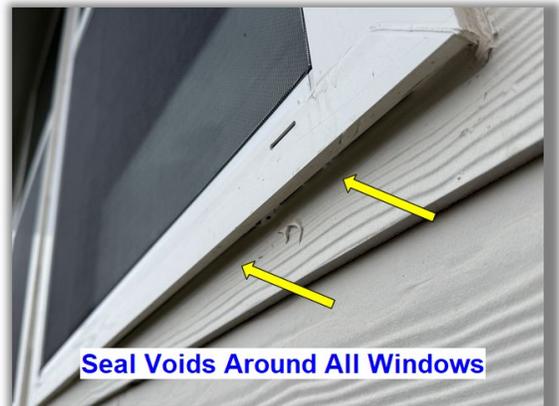
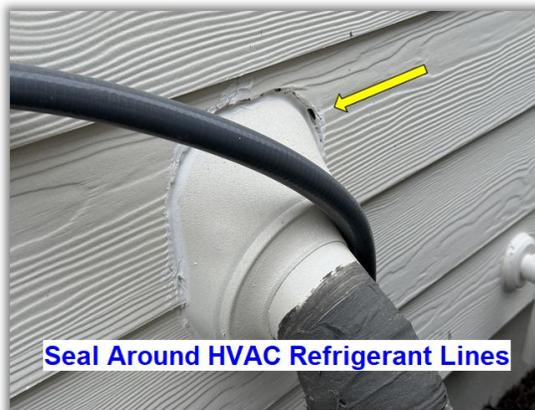
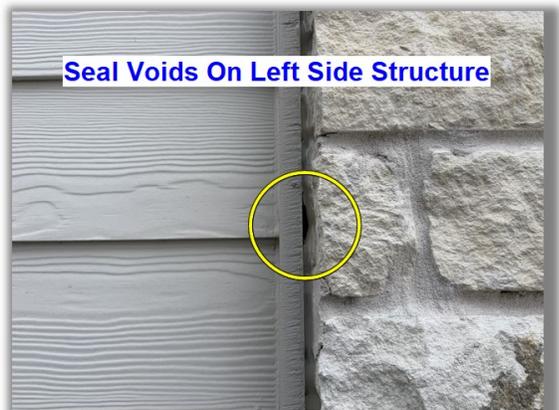
**Exterior Walls & Surfaces**

- Caulking improvements are recommended for the area between the exterior veneer and the garage door trim boards. It is recommended to use an industry approved low-modulus elastomeric sealant.
- Caulking improvements are recommended for the area between the exterior veneer and the window frames. It is recommended to use an industry approved low-modulus elastomeric sealant.
- The area between the exterior veneer and the outside HVAC condenser/coils refrigerant lines needs to be properly sealed.
- The exterior walls are not properly sealed where the fiber cement boards meet the stone veneer on the front and left sides of the structure.
- The stone veneer is not properly sealed at the frieze boards on the front, left, and right sides of the structure.

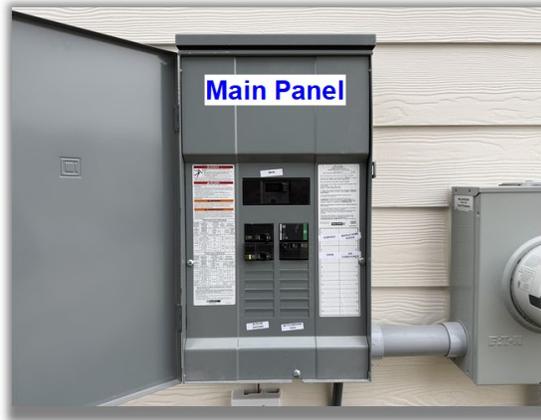
#### Distribution Wiring

- The electrical distribution lines and gas piping is in contact in the attic space and should be separated for safety reasons.

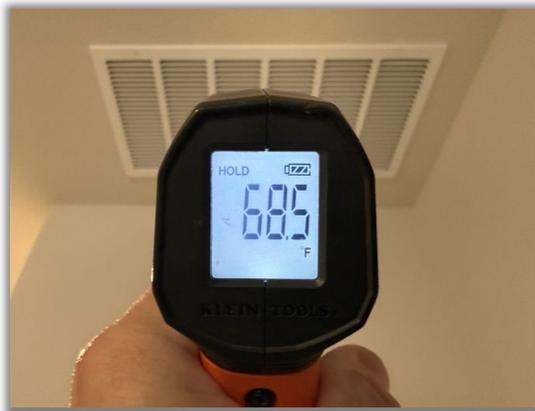
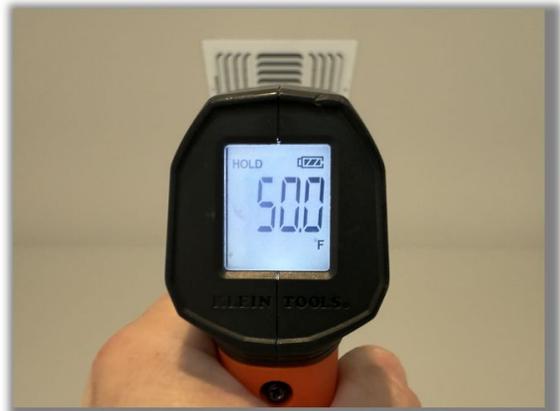
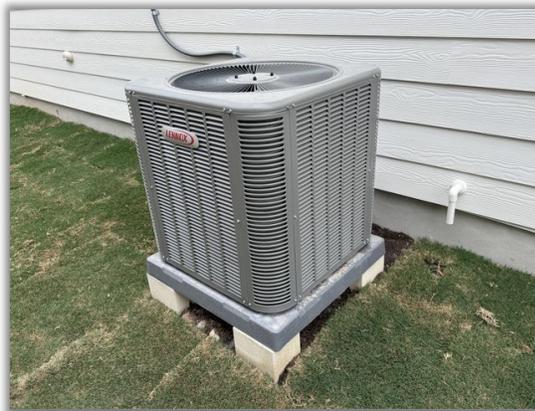
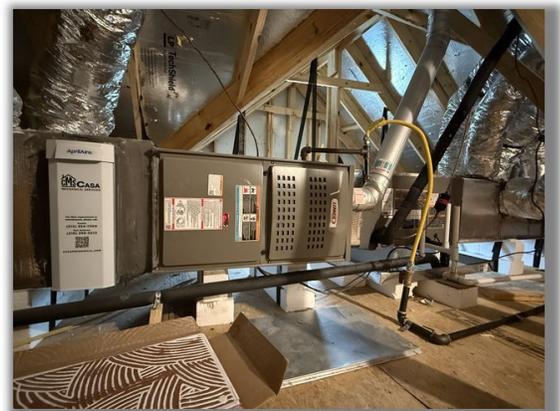
This component appears to be performing adequately at the time of this inspection.

This unit achieved an adequate temperature differential reading (Delta-T) as determined by accepted industry standard of practice for measuring cooling performance for air conditioning systems. This component is achieving an operation, function or configuration relative to accepted industry standard practices with consideration of age and normal wear and tear from ordinary use.

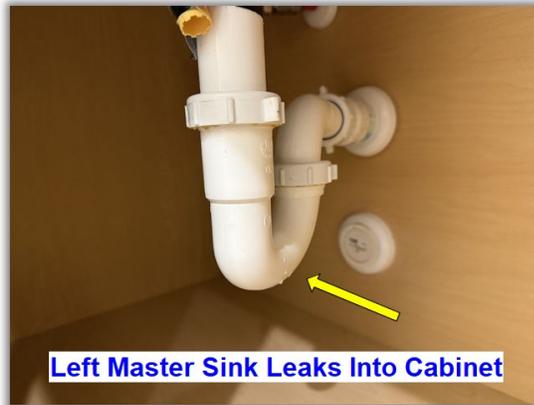
- The drain leaks water into the cabinet when drained under pressure with a large volume of water.

Left Master Sink Leaks Into Cabinet

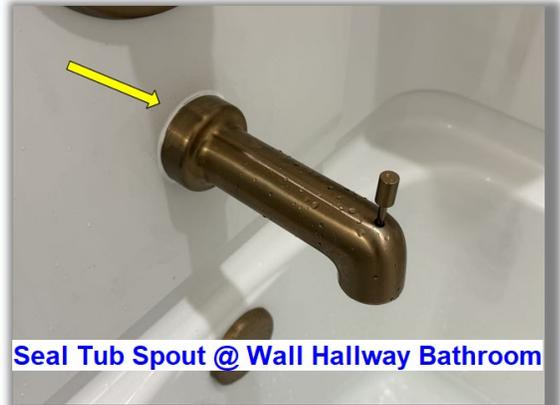
- The tub spout is not sealed at the wall. This condition has the potential to allow water to leak back into the wall cavity.

Seal Tub Spout @ Wall Hallway Bathroom

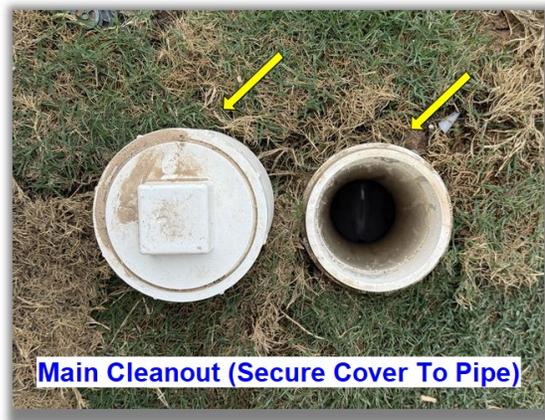
- The main cleanout cover is not properly secured and/ or glued to the rising pipe and should be corrected as needed.

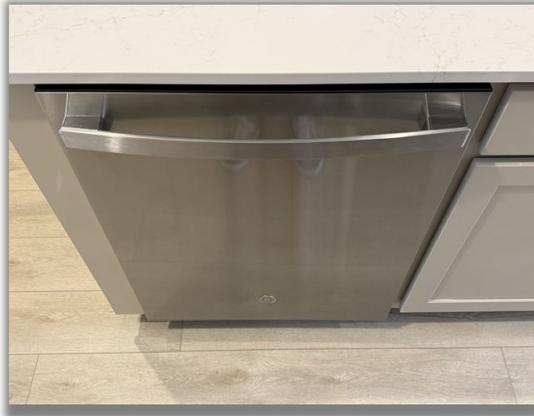
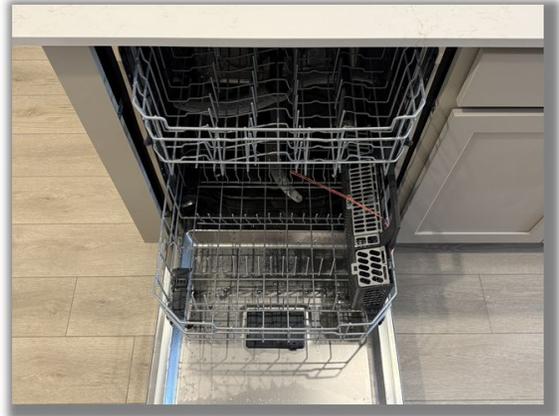
This component appears to be performing adequately at the time of this inspection.

It is achieving an operation, function or configuration relative to accepted industry standard practices with consideration of age and normal wear and tear from ordinary use.

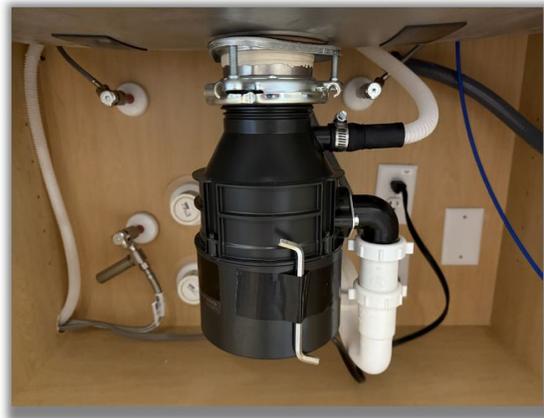
This component appears to be performing adequately at the time of this inspection.

It is achieving an operation, function or configuration relative to accepted industry standard practices with consideration of age and normal wear and tear from ordinary use.

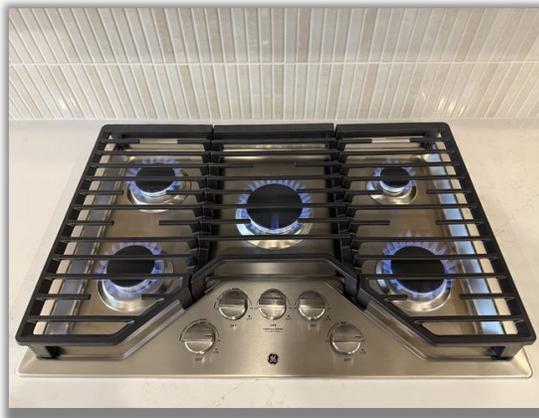
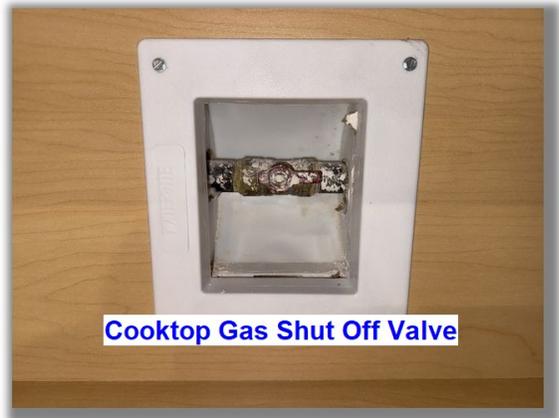
This component appears to be performing adequately at the time of this inspection.

It is achieving an operation, function or configuration relative to accepted industry standard practices with consideration of age and normal wear and tear from ordinary use.

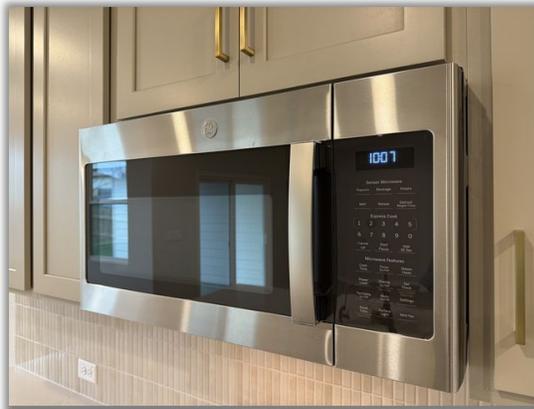
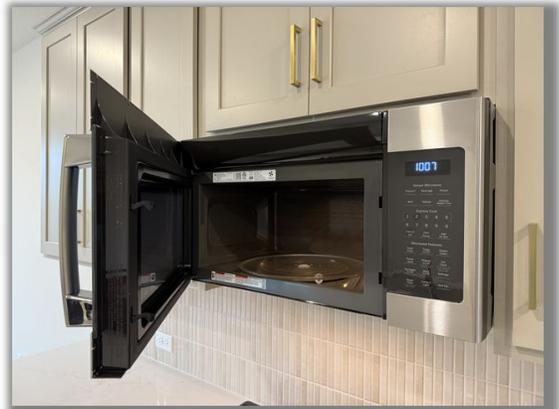
This component appears to be performing adequately at the time of this inspection.

It is achieving an operation, function or configuration relative to accepted industry standard practices with consideration of age and normal wear and tear from ordinary use.

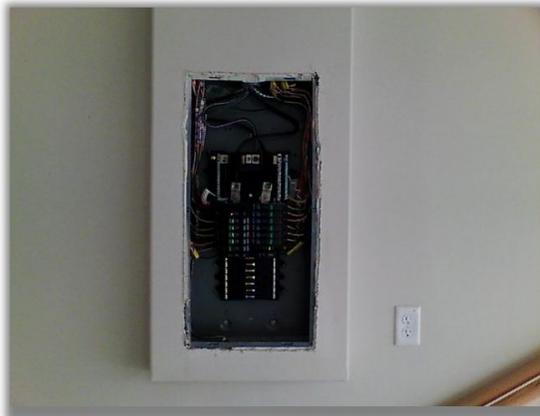
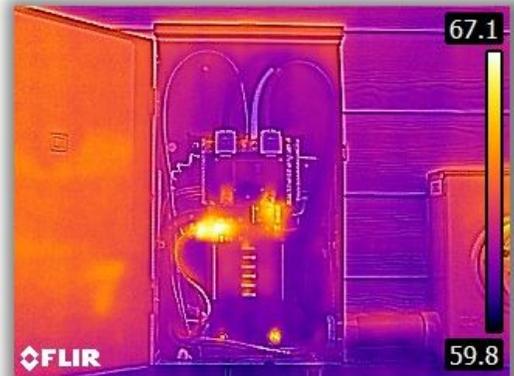
**Thermal Imaging / Infrared**

All components were found to be performing and in satisfactory condition on the day of the inspection.
